Hazard Alert

Oyster Barge Crane Boom

Hazard Summary

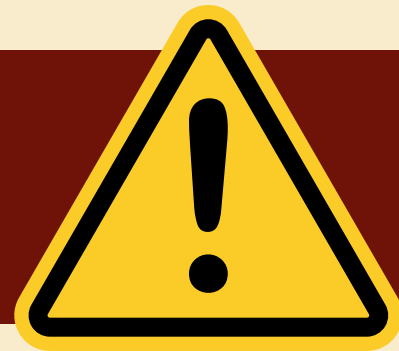
An oyster barge operator was killed when the barge's crane boom fell and struck his head. Although the crane was not in operation at the time of the incident, the operator happened to be positioned underneath it when the crane boom failed and spontaneously dropped.

- The rod of the cylinder was able to extend beyond the available space
- The high pressure safety valve did not release the pressure once the rod stopped moving
- The design of the crane mast caused restricted movement of the cylinder

These factors caused the piston rod to become overstressed, and it buckled and eventually fractured. In addition, the crane was positioned on the barge so that the operator needed to stand directly under the boom in order to operate the vessel's control panel.

- Be designed using an engineered design
- Be inspected and maintained on a regular basis to verify they are in safe working order
- Be positioned and designed to minimize overhead hazards for workers

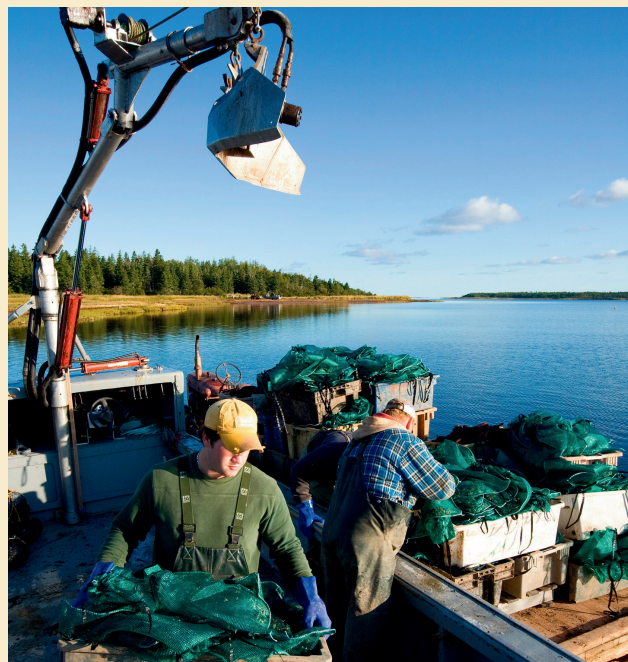
While it was a fairly new crane, it had been built without an engineered design. As a result:

It is recommended that cranes used on oyster barges:
